Inspection Report

Sample Report

123 Any Street
Canton, Ga. 30115

IHI Home Inspections, LLC

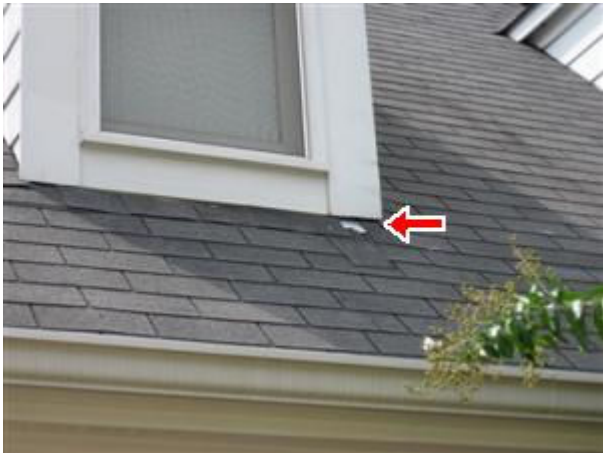
1.0 Picture 1

1.0 The Roof shingle has come loose & slid down at the left dormer. Unable to determine if this area will leak. I recommend repair as desired.

The Roof shingle has come loose & slid down at the left dormer. Unable to determine if this area will leak. I recommend repair as desired.

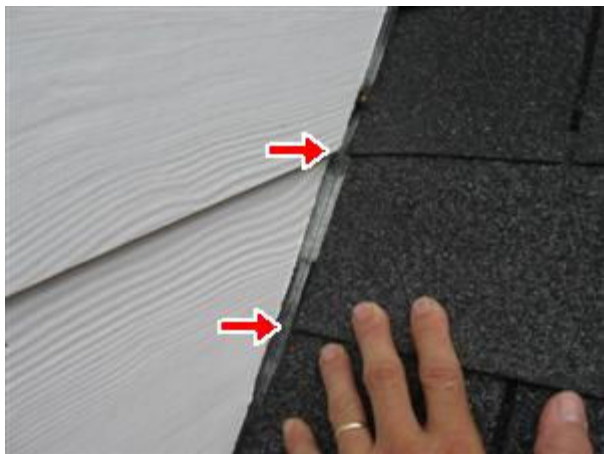
1.1 The roof is not flashed properly. The metal flashing did not weave under shingles (step flashing) and is improper. Unable to determine if this area will leak. A qualified roofing contractor should inspect further and correct as needed.

1.1 Picture 1 No step flashing. One piece flashing from top to bottom.

The roof is not flashed properly. The metal flashing did not weave under shingles (step flashing) and is improper. Unable to determine if this area will leak. A qualified roofing contractor should inspect further and correct as needed.

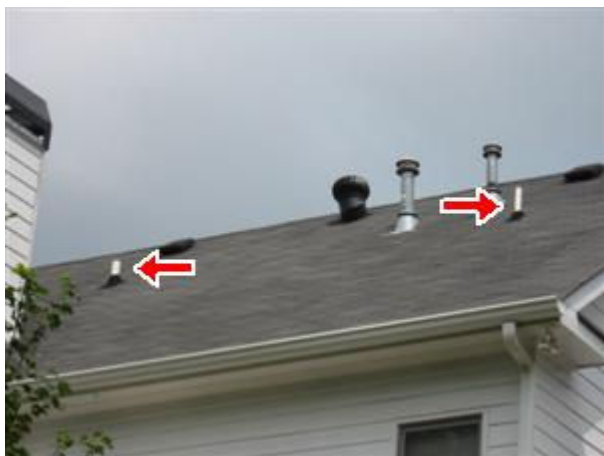
1.2 Plumbing vents coming thru roof need to be spray- painted black to protect from ultraviolet rays.

1.2 Picture 1 Plumbing vents need painted black

Plumbing vents coming thru roof need to be spray- painted black to protect from ultraviolet rays.

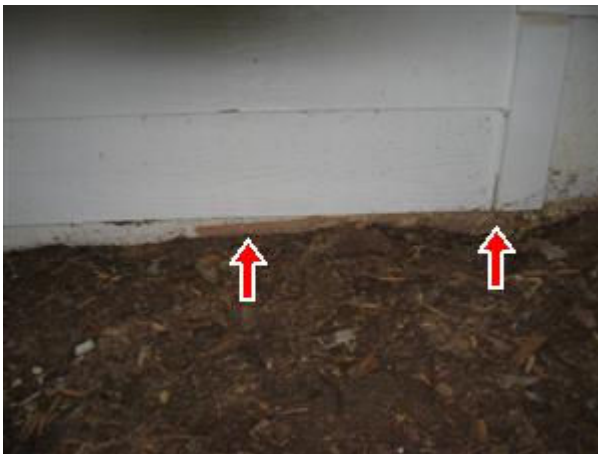
2.0 Picture 1 Grade to close to siding under deck.

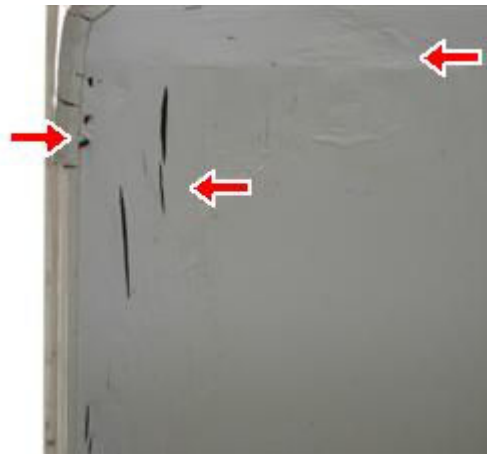
2.0 Picture 2 Plywood under bay window is roted & needs replacing.

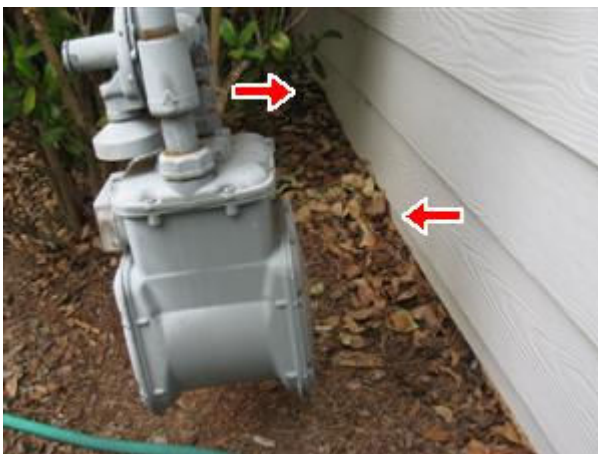
**2.0** (1) Siding in contact with ground at right side of house. Because the siding is in contact with ground it is possible for framing to be deteriorated. We did not inspect behind this siding. Recommend a ground clearance of six to eight inches where possible.

2.0 Picture 3 Siding in contact with ground.

(1) Siding in contact with ground at right side of house. Because the siding is in contact with ground it is possible for framing to be deteriorated. We did not inspect behind this siding. Recommend a ground clearance of six to eight inches where possible.

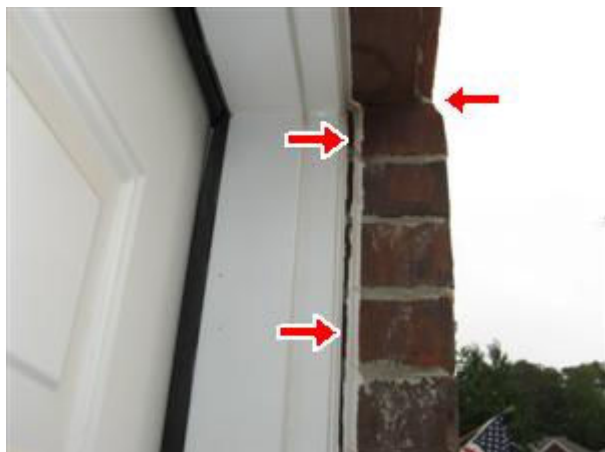
2.0 Picture 4

(2) Brick column between garage door & walk thru door has separated from above & is leaning out. Needs evaluated by masonry contractor & repaired as needed.

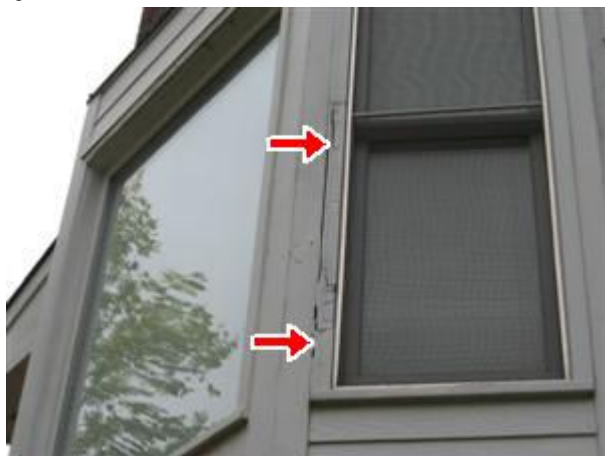
**2.2** (1) The brick-mold deteriorated at bay window & at back deck. Further deterioration may occur if not repaired. A qualified person should repair or replace as needed.

2.2 Picture 1 brick-mold deteriorated needs replaced.

(1) The brick-mold deteriorated at bay window & at back deck. Further deterioration may occur if not repaired. A qualified person should repair or replace as needed.

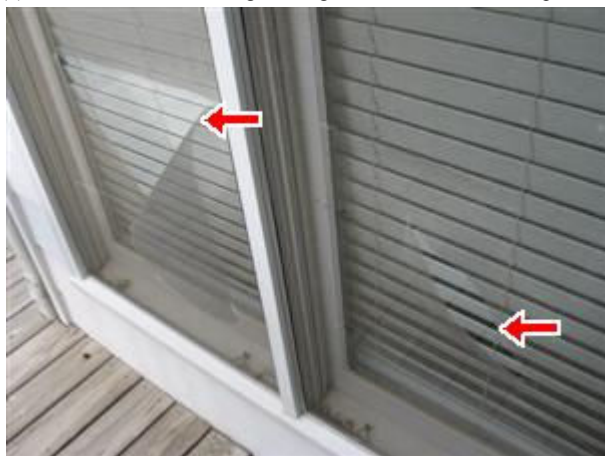
(2) Several screens are damaged along back of house & need replaced. FYI This is a cosmetic issue.

2.2 Picture 3 Several screens are damaged along back of house.

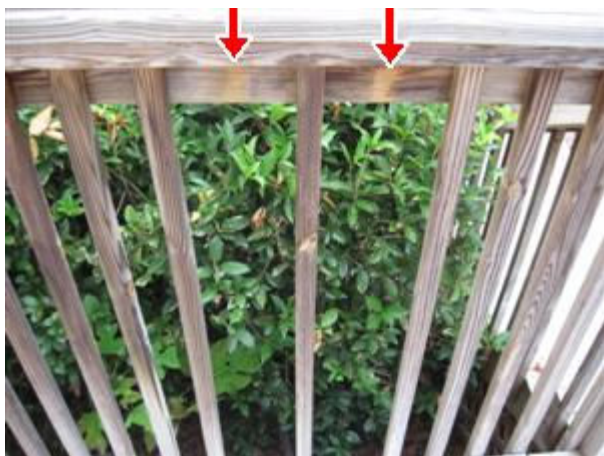
2.3 Picture 1

**2.3** (1) Some pickets on deck at the rear of home are missing . An injury could occur if not corrected. The maximum space between pickets should be four inches.

(1) Some pickets on deck at the rear of home are missing . An injury could occur if not corrected. The maximum space between pickets should be four inches.

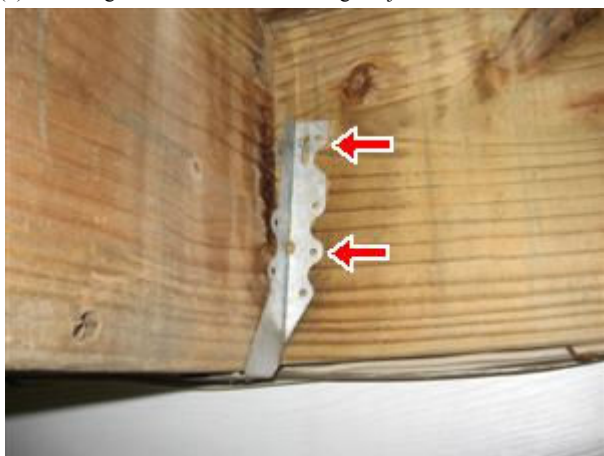
(2) Joist hanger under deck needs nailing not just one side but both.

2.3 Picture 2 Joist hanger under deck needs nailing not just one side but both.

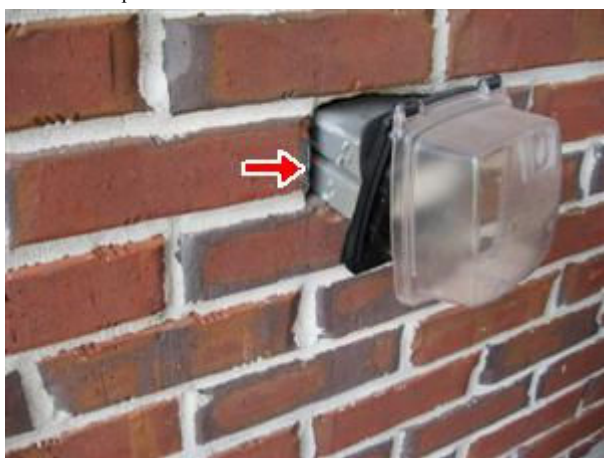
**2.7** The exterior outlet at the front door is loose in the wall, and needs to be secured properly. Electrical issues are considered a hazard until repaired. I recommend repair as needed.

2.7 Picture 1 Outlet needs secured in wall.

The exterior outlet at the front door is loose in the wall, and needs to be secured properly. Electrical issues are considered a hazard until repaired. I recommend repair as needed.

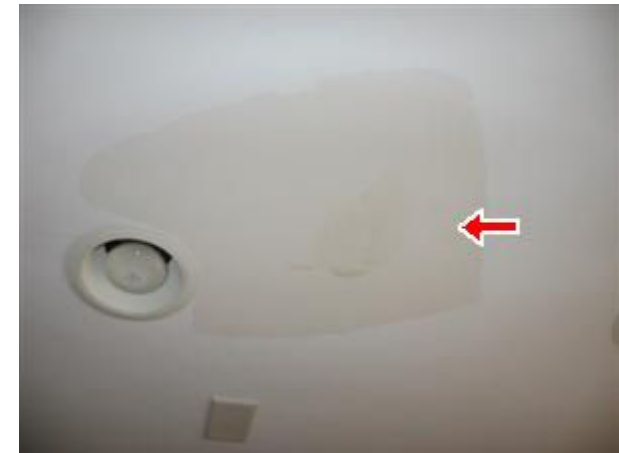
**4.0** Homeowner states leak has been repaired. The Sheetrock on the ceiling reveals a water stain indicating a leak did or still exists and shows repair signs at the kitchen. This damage is considered cosmetic. I recommend prep prime and paint as needed.

4.0 Picture 1 Homeowner states leak has been repaired.

Homeowner states leak has been repaired. The Sheetrock on the ceiling reveals a water stain indicating a leak did or still exists and shows repair signs at the kitchen. This damage is considered cosmetic. I recommend prep prime and paint as needed.

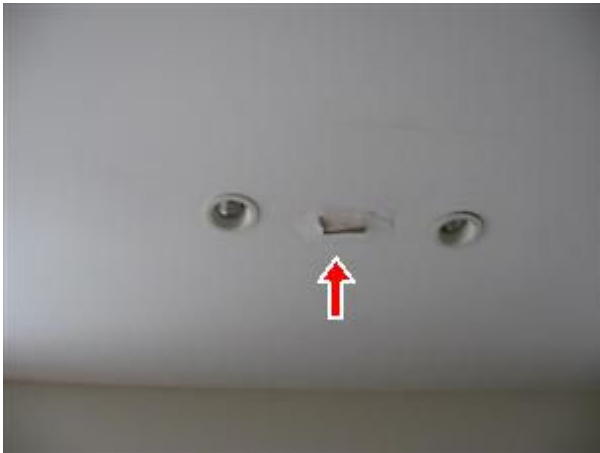
5.0 (1) The Sheetrock on the ceiling is peeling as a result from water leak above at the Living Room. This is a cosmetic issue for your information. I recommend repair as desired.

5.0 Picture 1 Homeowner states leak has been repaired.

(1) The Sheetrock on the ceiling is peeling as a result from water leak above at the Living Room. This is a cosmetic issue for your information. I recommend repair as desired.

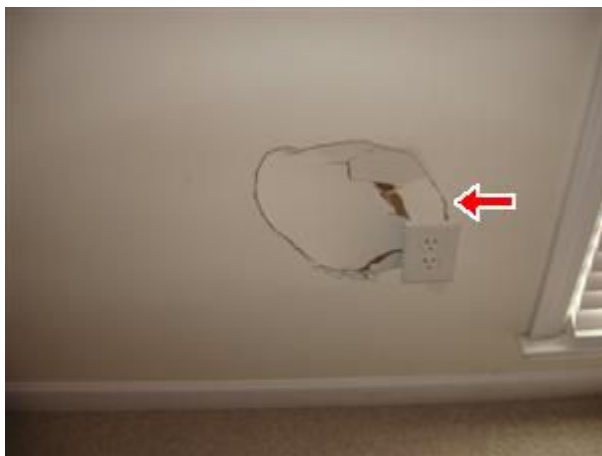
**5.1** Hole in master bedroom wall needs repairing.

5.1 Picture 1 Hole in master bedroom wall.

Hole in master bedroom wall needs repairing.

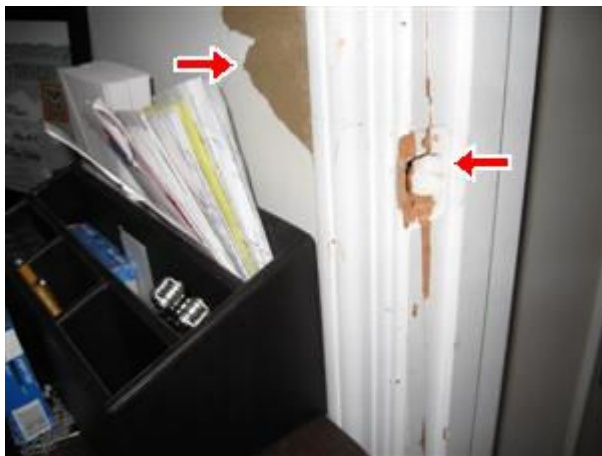
5.4 Picture 1

**5.4** Upstairs right front corner bedroom door frame busted, door hinges separated from frame, needs total replacement.

Upstairs right front corner bedroom door frame busted, door hinges separated from frame, needs total replacement.

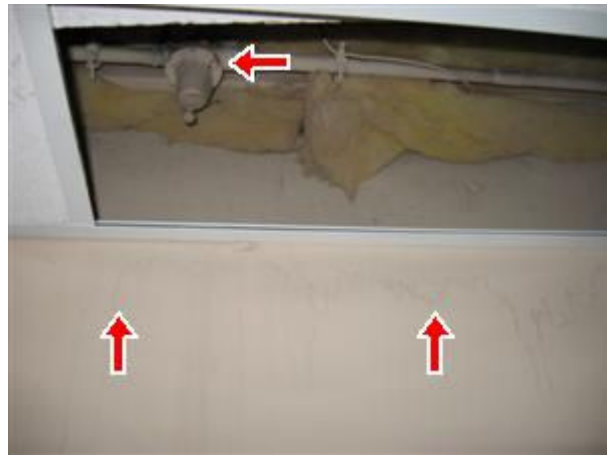
8.1 Picture 1

**8.1** The PRV (pressure reducing valve) is leaking in the basement ceiling onto the wall. Repairs are needed. A qualified person should repair as necessary.

The PRV (pressure reducing valve) is leaking in the basement ceiling onto the wall. Repairs are needed. A qualified person should repair as necessary.

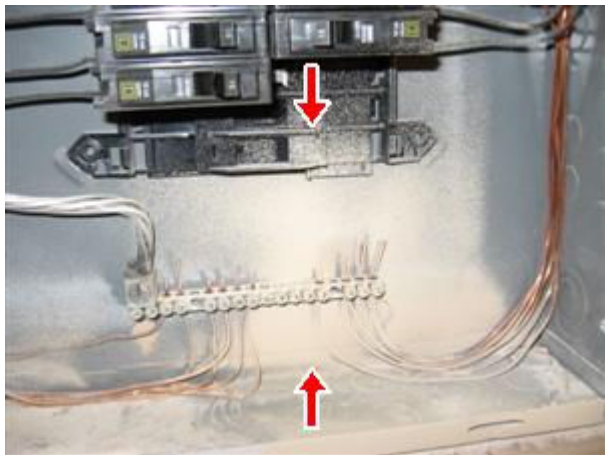
9.1 Picture 1

**9.1** The problem discovered in the sub panel in basement is contamination of the panel from paint over spray, panel needs replacing. I recommend a licensed electrician inspect further and correct as needed.

The problem discovered in the sub panel in basement is contamination of the panel from paint over spray, panel needs replacing. I recommend a licensed electrician inspect further and correct as needed.
